CONDITION SURVEY, MARCH AIR FORCE BASE, CALIFORNIA

R. D. Jackson

June 1973

Conducted by U. S. Army Engineer Waterways Experiment Station
Soils and Pavements Laboratory
Vicksburg, Mississippi

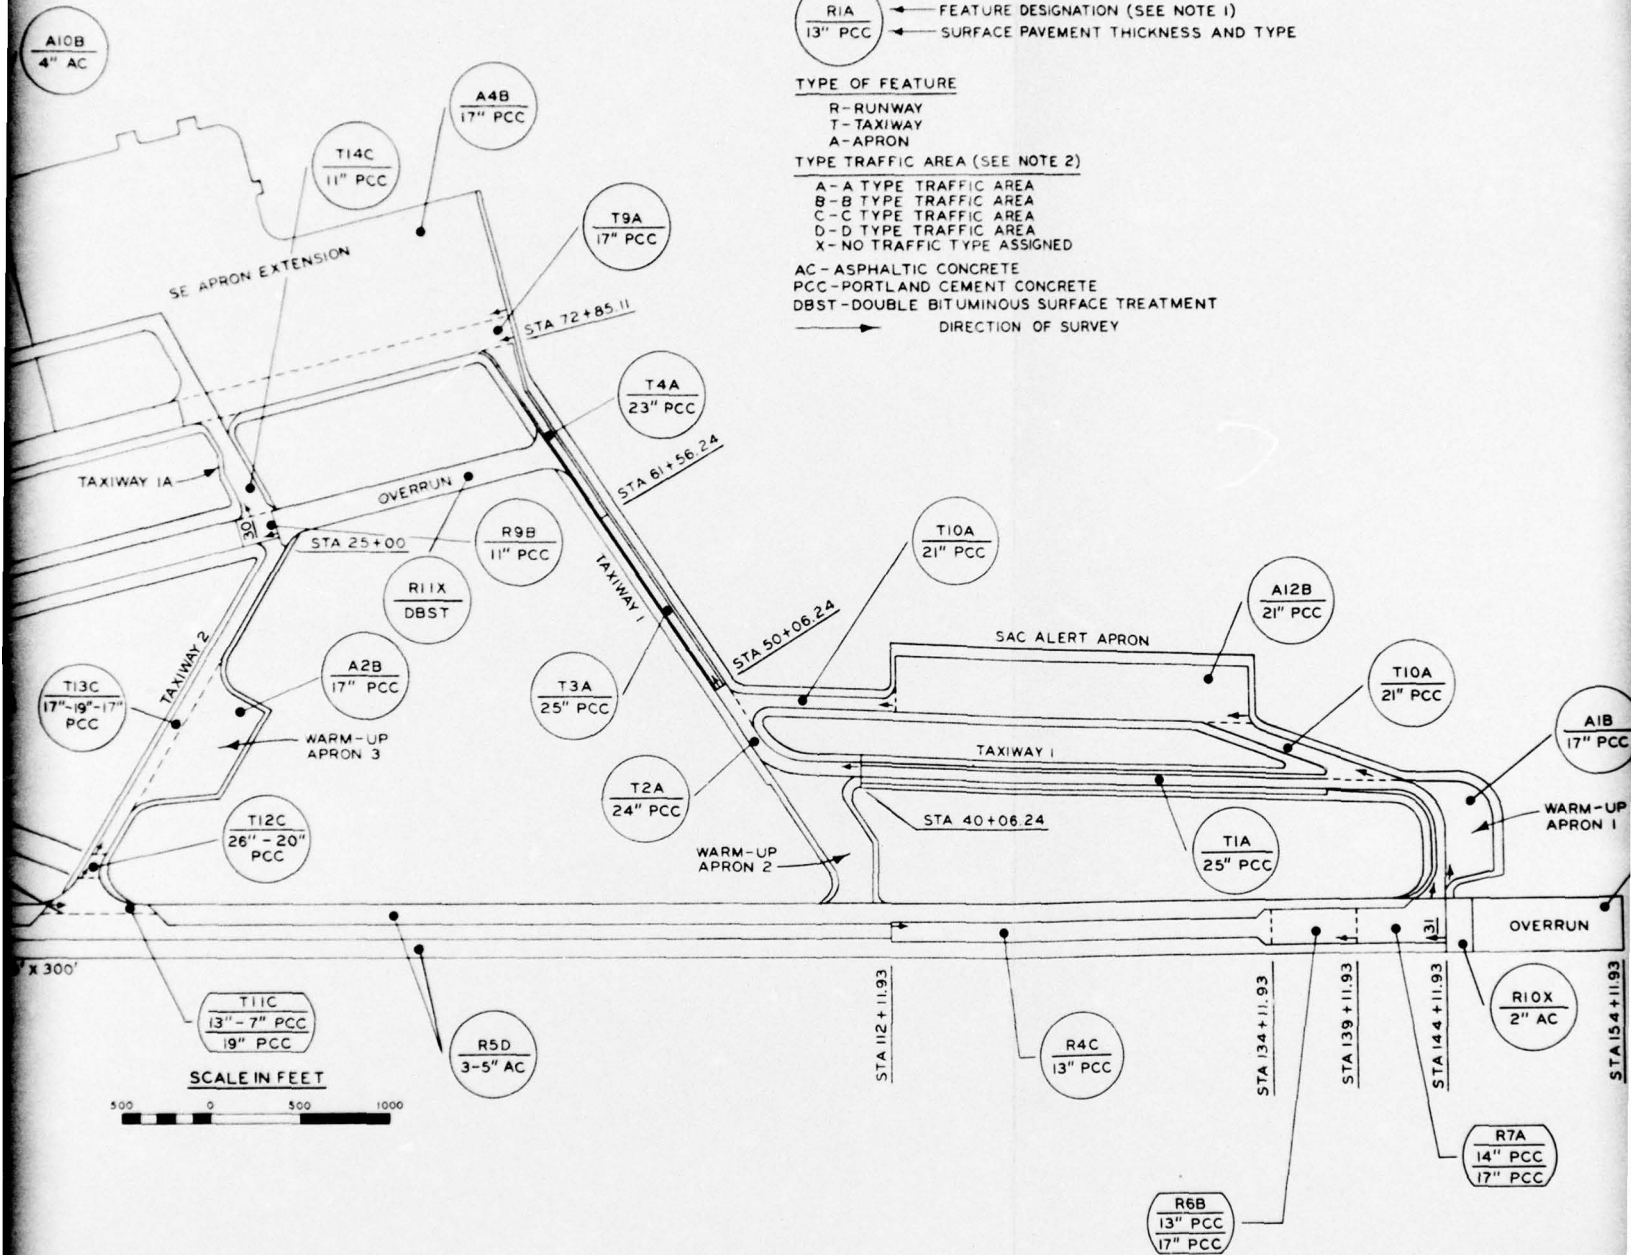
the pavements were inspected (shown by arrows) are indicated in plate 1. The results of the rigid pavement survey for those features that were inspected in detail are presented in table 4. This table shows a quantitative breakdown of the various types of defects and a condition rating for each feature inspected in detail. The procedures used for determining the condition rating of a pavement are given in Appendix III of Department of the Army Technical Manual TM 5-827-3, "Rigid Airfield Pavement Evaluation," dated September 1965.
